Increasing the Efficiency of De Dusting Car at Recovery Coke Ovens

Abstract- De-dusting car frequently getting under capital repair at recovery coke ovens and also leakages are causing temperature variation of control vertical temperature in battery. The de dusting car is used for reduction of emission while charging, after some duration performance gets degraded and thus stack emission raise. Mainly emissions and capital repair arises due to the distortion of de-dusting car water jackets and refractory casting. “DOWNTIME” is happening every 6 months ,this is because of water cooling duct and ceramic casting distortion also leads to huge “EMISSION” from stack .hence there is rise of frequent maintenance in de-dusting car. De-dust car is the movable dust-collecting & dust-removing device While coal charging. Working principle of the equipment: while coal charging, guide sleeve of de-dust car aims at flue guide hole on the top of chamber to collect flue & dust, by turns enter into combustion chamber, connecting pipe, spray room, Venturi tube, cyclone separator, blower, then exhaust into the air. It improves equip level of coke oven and decrease flue & dust exhaust. De-dust car trans

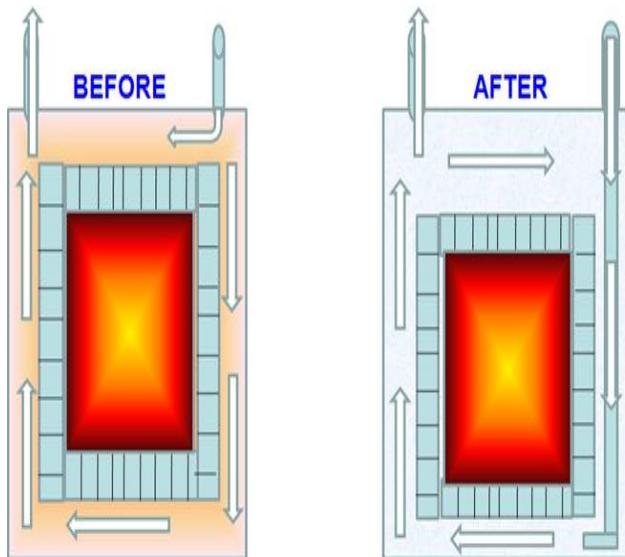
The problem generated because of less area of water cooling jacket and making difficulty in circulation of hot water out, this hot water "retaining time" is increased inside the cooling jacket , which can damage the cooling duct when hot gas come in contact with the system. Also the ceramic casting is deformed frequently.

Fig -7 water jacket

4. **Solution:** Increase in volume only on top of cooling chamber and inlet pipe extended inside the water cooling jacket thus the circulation process is free and cooling "retaining time" is increased.

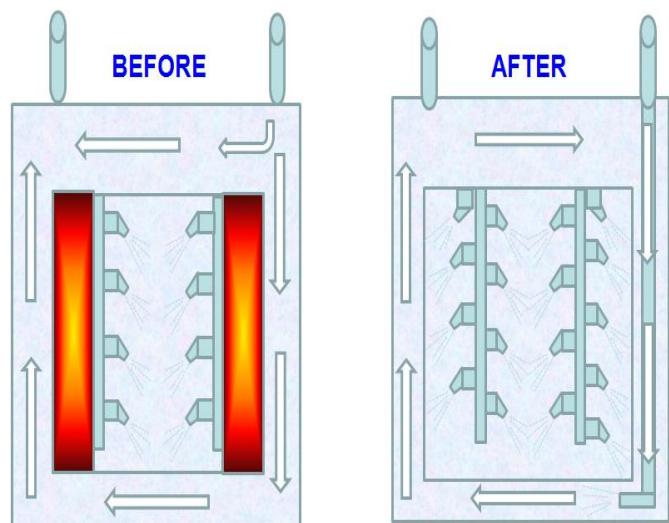
Fig -8 nozzle increases

4. Solution: Increase the spray nozzle from 8 to 14 nos. at the direction of wall of jacket and the two extra nozzles from the tapping of the water jacket.

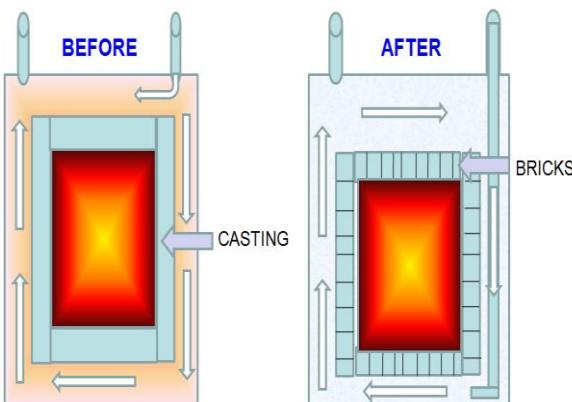
Fig-9 casting

Remarks: replacing of casting material with high grade ceramic brick which will protect from all deviation naturally the performance increases.

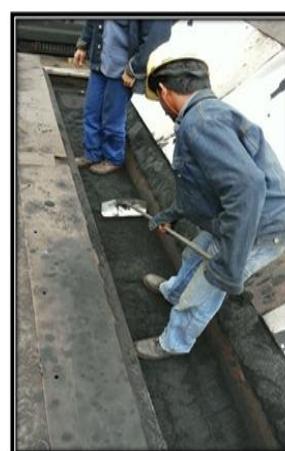
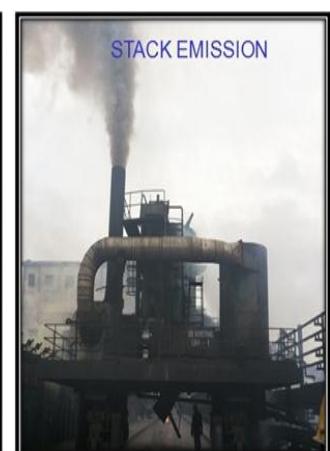
Fig 10 stack emission

Emissions found during start of charging after foot pressing so for this problem we did Why Why analysis for find the problem

Implementation of "RAMMER" to stamp the loose coal which is found on top layer of the cake made.

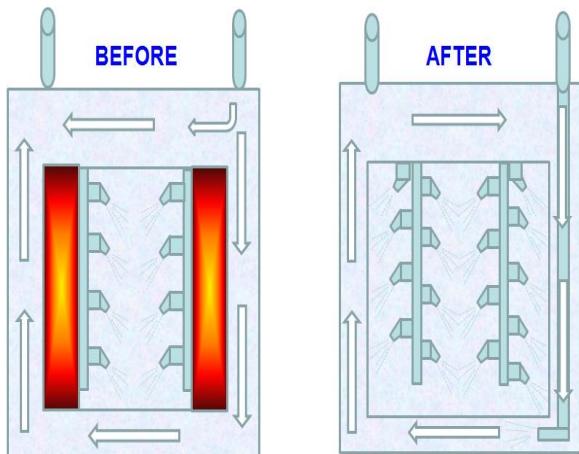
Fig 12 nozzles

Trial 2:- the water is being sprayed to both vertical horizontal nozzles.

Remarks: - Required reduction in outlet gas temperature was improved.
