Comprehensive Traffic Study and Improvement Strategies for Paripally - Paravoor Road

Abstract— This study evaluates the existing traffic conditions on the Paripally–Paravoor Road and proposes appropriate improvement strategies to enhance safety, efficiency and mobility. The corridor serves as an important link between Paripally and Paravoor carrying a significant volume of heterogeneous traffic including two-wheelers, cars, buses, goods vehicles and pedestrians. Traffic data were collected through detailed volume surveys classified vehicle counts and peak hour analysis. Passenger Car Unit (PCU) values were computed to standardize traffic flow characteristics. Congestion points and accident-prone locations (black spots) were identified through field observations and supporting data. In addition, key roadway features such as geometric design, intersection conditions and roadside characteristics were assessed to determine their influence on traffic performance and safety. Based on the analysis, suitable traffic engineering and management measures are proposed including road widening at critical sections, improved traffic signage, provision of pedestrian safety facilities and signaliz

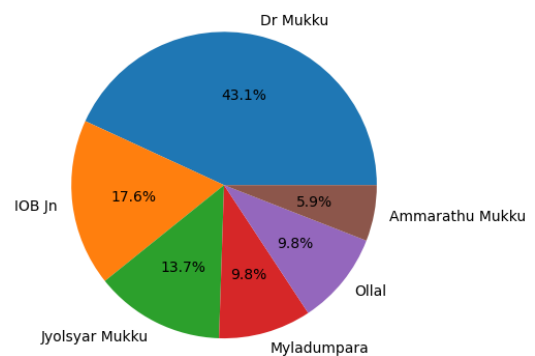
Accident Distribution by Area (2025 - Top 6)

The accident distribution along the Parippally–Paravur road corridor indicates a pronounced spatial concentration at selected junctions. Dr Mukku accounts for the highest share of accidents, increasing from 35.7% to 43.1% in 2025 thereby confirming its identification as a major black spot. IOB Junction and Jyolsiyar Mukku exhibit moderate accident frequencies reflecting localized traffic conflicts and operational inefficiencies. In contrast Ollal and Myladumpara contribute relatively lower shares but remain significant from a safety perspective.

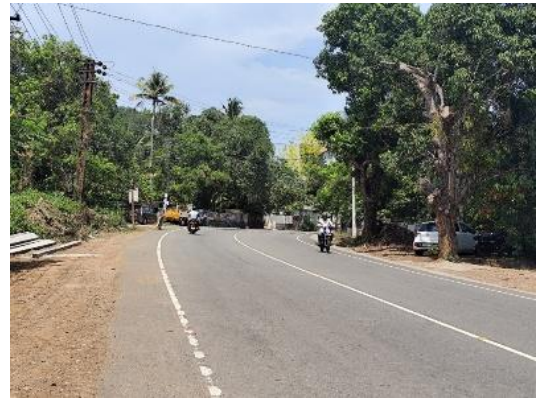
Fig: Dr. Mukku

The location shows a horizontal curve with roadside hazards such as trees, utility poles and materials placed close to the carriageway reducing sight distance and effective shoulder width. As per IRC:38, adequate stopping sight distance is not maintained due to these obstructions. The presence of fixed objects within the clear zone violates IRC:79 and IRC:119 guidelines requiring removal or protection using crash barriers. Inadequate shoulder width also contradicts IRC:73 recommendations. Additionally, proper warning signs and curve delineation as per IRC:67 is insufficient. Recommended measures include clearing obstructions, providing paved shoulders, installing chevron boards and signage and implementing speed control measures as per IRC:99 to improve safety.

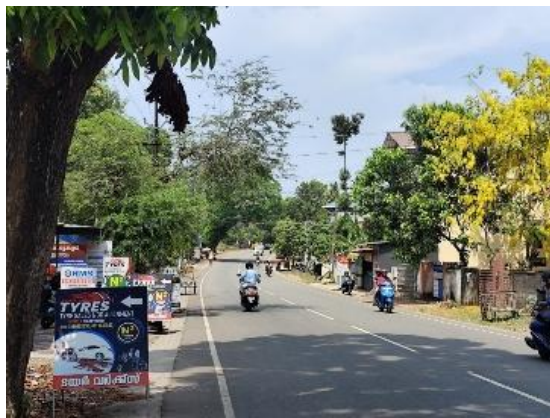
Fig: Dr. Mukku

Location shows a roadway safety issue due to unauthorized roadside advertisement boards and vegetation placed close to the carriageway obstructing visibility and reducing effective shoulder width. As per IRC:67, traffic signs and roadside elements must not obstruct driver visibility, but these boards create distraction and sight distance issues. The presence of objects within the roadside clear zone violates IRC:79 guidelines.

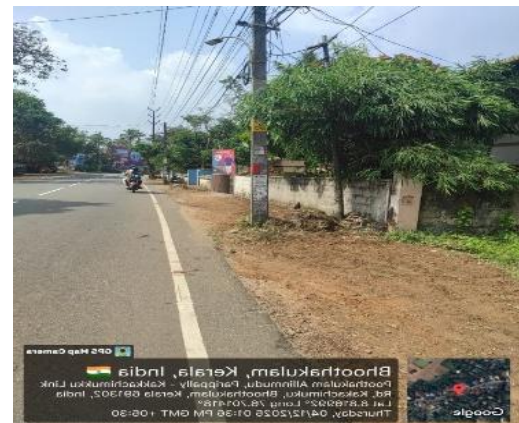
Fig: Dr. Mukku

Shows a roadside safety issue due to electric poles placed very close to the carriageway and vegetation encroaching into the shoulder reducing effective road width and posing collision risks. This violates IRC:32 requirements for adequate horizontal clearance and IRC:79 guidelines for maintaining a safe clear zone. The unpaved and uneven shoulder also contradicts IRC:73 recommendations. Additionally, lack of proper hazard markings and signage as per IRC:67 increases accident risk. Recommended measures include relocating poles or providing crash barriers (IRC:119), clearing vegetation, developing a paved shoulder and installing proper warning signs and markings to enhance safety.
