International Journal of Recent Development in Engineering and Technology
Website: www.ijrdet.com (ISSN 2347-6435 (Online) Volume 15, Issue 04, April 2026)

Assessment of Gully Erosion Dynamics and Environmental Impacts in the Ankpa–Ajobe Area, North-Central Nigeria.

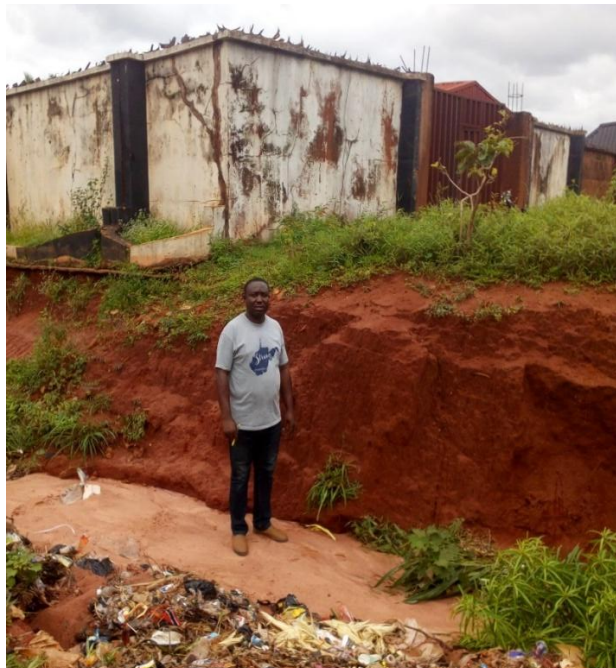
Figure:5 Field photograph of gully site in Olubojo Ankpa

Large portions of farmland have been destroyed, reducing crop productivity, destruction of infrastructure, and threat to residential areas. Several communities, such as Olubojo Fig 5a and b Owelle, have been severely affected for a long time. Roads, schools, hospitals and other rural infrastructure have been severely affected.

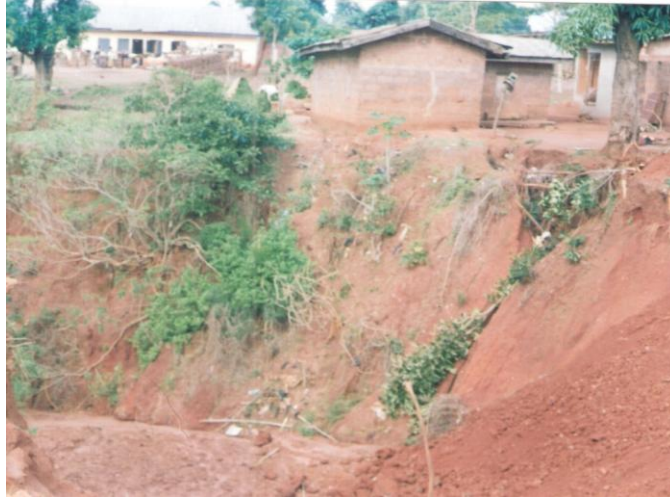
Fig 5b gully site in owelle Ankpa
