Increasing the Efficiency of De Dusting Car at Recovery Coke Ovens

Abstract- De-dusting car frequently getting under capital repair at recovery coke ovens and also leakages are causing temperature variation of control vertical temperature in battery. The de dusting car is used for reduction of emission while charging, after some duration performance gets degraded and thus stack emission raise. Mainly emissions and capital repair arises due to the distortion of de-dusting car water jackets and refractory casting. “DOWNTIME” is happening every 6 months ,this is because of water cooling duct and ceramic casting distortion also leads to huge “EMISSION” from stack .hence there is rise of frequent maintenance in de-dusting car. De-dust car is the movable dust-collecting & dust-removing device While coal charging. Working principle of the equipment: while coal charging, guide sleeve of de-dust car aims at flue guide hole on the top of chamber to collect flue & dust, by turns enter into combustion chamber, connecting pipe, spray room, Venturi tube, cyclone separator, blower, then exhaust into the air. It improves equip level of coke oven and decrease flue & dust exhaust. De-dust car trans

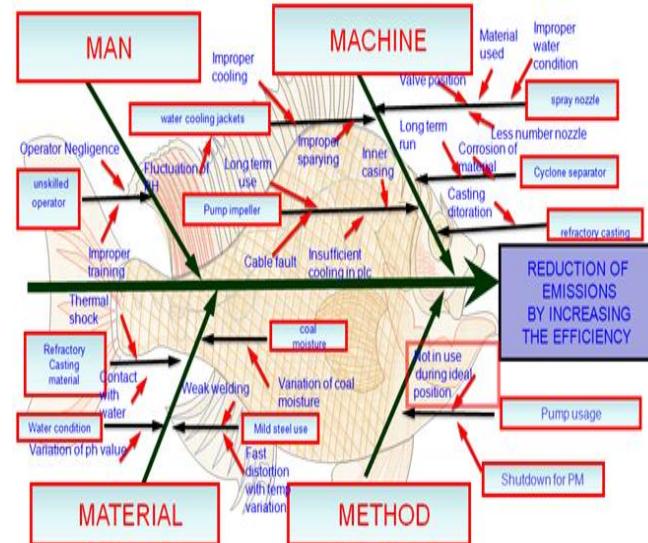
Fig 5. Root cause for emissions

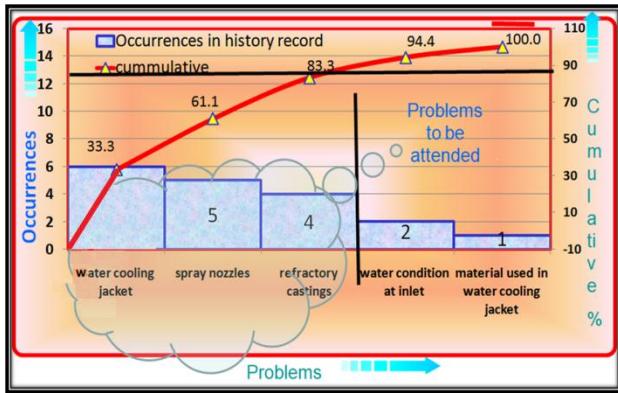
Based on the available data from occurrence chart a Pereto Chart was prepared as shown below in fig from which we concluded that these three causes water cooling jacket, spray nozzles, refractory castings Were responsible for the emissions from De-dusting car and contributing up to 80% of the problem.

Fig -6 occurrences

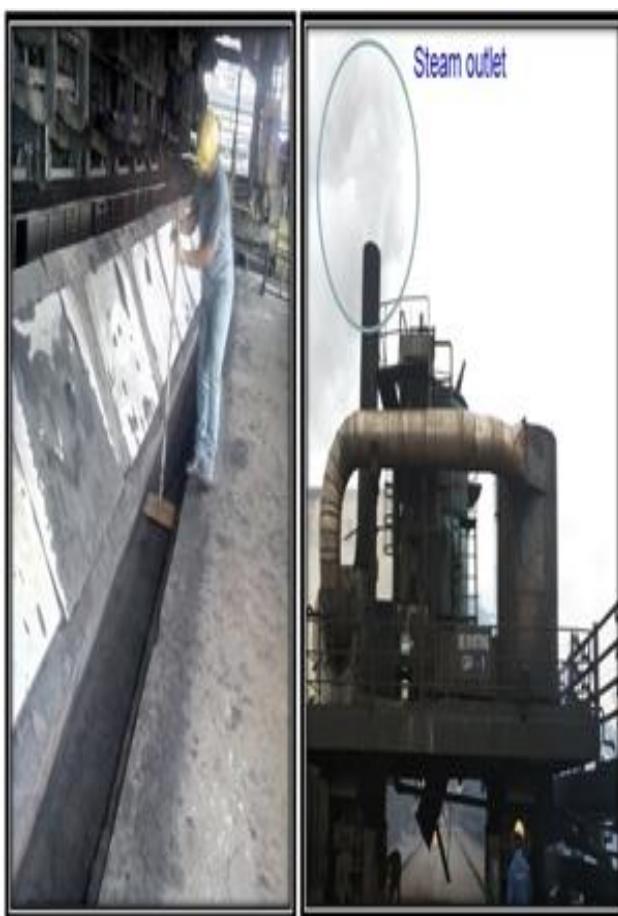
Fig -11 after results

This occurrence chart is the comparison of before & after our project which clearly show all the problem have been uniformly distributed as seen in table 8.3.
