Repair of PCCP By the Gunnite Method

Abstract— Repair affected pipes with mortar coating delaminating using the Gunnite method, where the method applied on the affected pipes which the surface area of affected Coating delaminating reach up to entire pipe body, this method applied on more than 480 affected pipes in Man-Made River Project in desert of Libya.

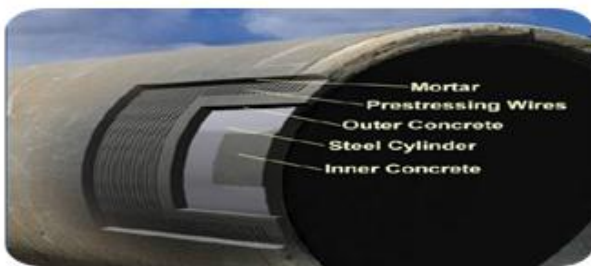
The Man-Made River Project (MRA) is one of the largest water projects in the world. It consists of 4000 Km (2485 miles) of mainly (4.00 meter) (158-inch) diameter, and other various of diameters as (1.60, 2.00, 2.80 and 3.60 meter) (63, 79, 110 and 142 -inch) pre-stressed concrete cylinder pipe (PCCP), fig (1) components of PCCP and can convey over 6 million cubic meters of water per day from well fields deep in the Sahara Desert to the populated areas on the coast and divided in main four phases.

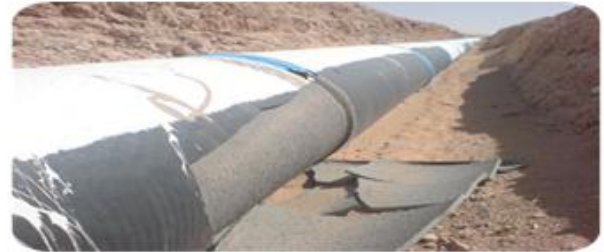
Coating delamination occurred in some of the highly prestressed 1600 mm diameter prestressed concrete cylinder pipe (pccp) manufactured by Al Nahr company (ANC) at Brega plant. Coating delamination manifests itself by hollow sound when the mortar coating is tapped with a light hammer.

The hollow sound appeared after a few months from coating operation when the pipes were stored in the stockyard at Brega Plant or in the stockyard or windrow prior to installation or after installation and prior to backfilling operation. The hollow sound appeared to be starting at the spigot end of the pipe fig(2).
