# Analysis of Industrial Process in the Electronic Industry of Mexicali

**Abstract--** In the manufacturing processes of the electronics industry developed by electrical and electronic equipment and systems, there are variations that indicate the different types of causes that may manifest themselves. These changes in the operating specifications of industrial machinery can happen because electrical failures sometimes occur continuously or in certain daily, weekly and monthly periods. The analysis are carried out at this time mainly to know the operational performance (RO) of the equipment and systems of companies of the electronic turn. This generates imbalances in the planning activities in the programming of the different types of products that are manufactured and with it the decrease of manufactured units and in the majority of the times, economic losses occur. Being the city of Mexicali, a region of the northwest of Mexico where they are installed great amount of industrial plants of the electronic branch, a study with the objective of determining the main causes of the generation of electrical faults of the industrial machinery was developed. The most important tool used wa

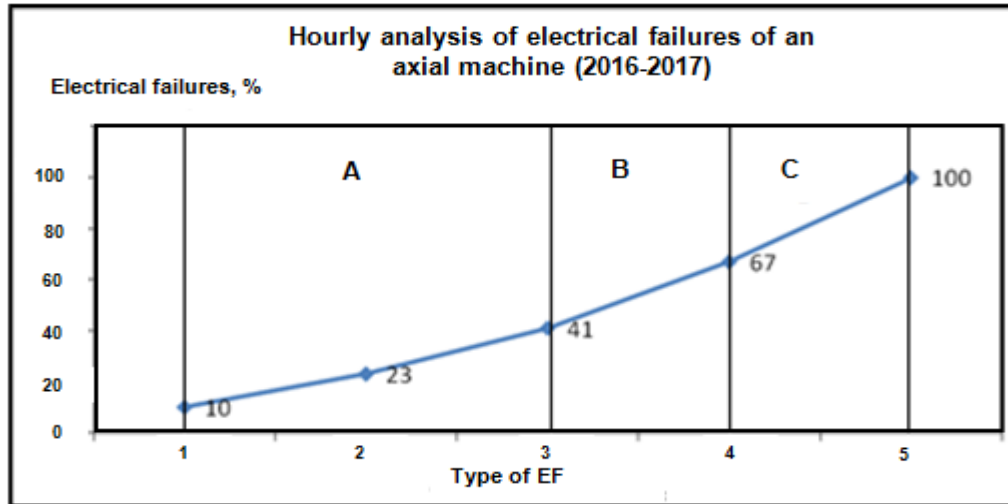
**Figure 1 Hourly evaluation of electrical failures generated in an axial machine (2016-2017)**

Figure 1 show the analysis of the incidence of electrical failures in the axial machine in a hourly period, where it is observed that the first two types of EF represent 41% in 67%, being the zone A. In region B of the graph, it indicates a level of 26% and combined to zone A are the highest range electrical faults being the first four of the FE types evaluated being expressed by zone B. Zone C shows the percentage complement at 100%, of the last type of FE. In this evaluation indicates according to the percentages which of the failures can be found an early solution or determine which is the easiest to solve to avoid unemployment of activities in production and thus economic losses.

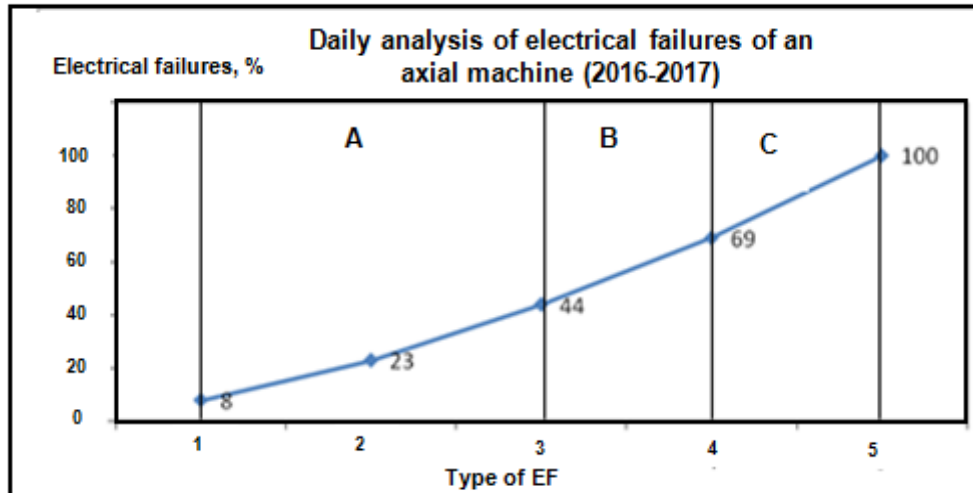
In Figure 2, the same process occurs as in Figure 1, the percentages being a little different in each area shown represented the daily period. This analysis supports having the vision of how to prevent industrial machinery from ceasing to operate. In zone A of figure 2, the percentage of the first three types of FE is 44%, with 25% being the percentage index and together with the previous failures of this graph, they complement the 69% indicated by zone B. Finally, there is zone C, with a difference of 31% from zone B, and representing the total level of FEs in this evaluation. This analysis is of the axial machine in the daily period.

Figure 2 Daily evaluation of electrical failures generated in an axial machine (2016-2017)

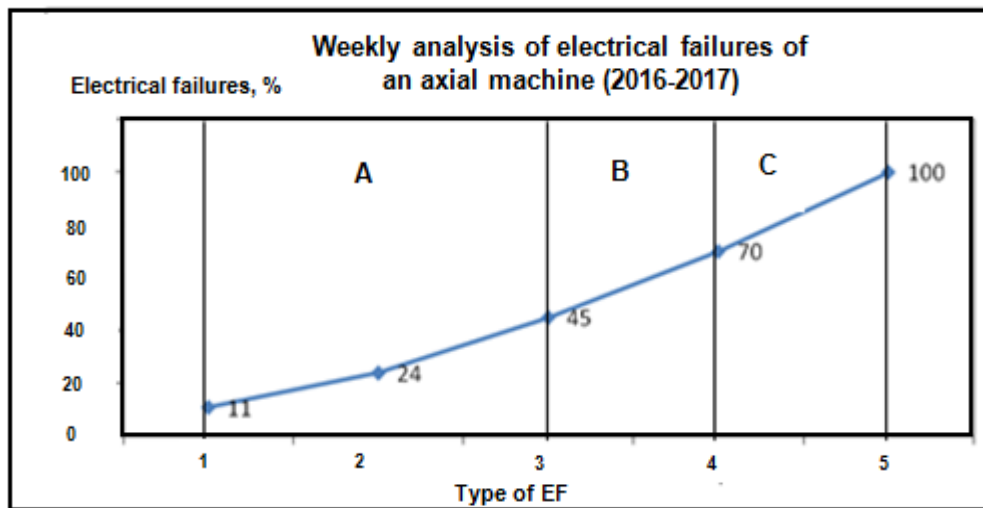
Figure 3 Weekly evaluation of electrical failures generated in an axial machine (2016-2017)

The previous graph that is figure 3 is part of the weekly evaluation in the axial machine of the weekly period, indicating that the three first types of failures represent 45%, being a little similar to the two graphs 1 and 2, being this the zone A, continuing with zone B that shows a percentage of 70%, this analysis being where the highest percentage level in this area is presented with respect to the hourly, daily, weekly and monthly evaluations. Finally we have zone C to obtain the final percentage, being a difference of the region before the C of 30%.

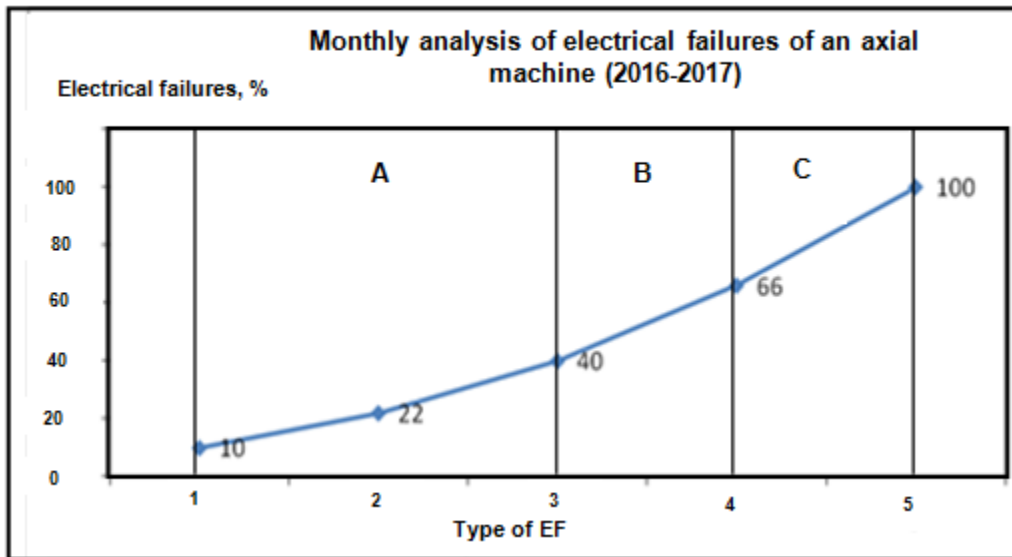
Figure 4 indicates that represent the monthly period, the zones of graph A, B and C, with the first three types of FE with 44% that is region A, following with zone B combined with the A of 66% and finalizing the analysis with the area C representing a difference of the previous zone at the end of 34%. Figure 5 is part of the evaluation of the radial machine in the hourly period, where it is observed that the first three types of electrical faults represent the 44% that is zone A, continuing with region B that reaches 69% and by last zone C reaching the total percentage of 100%.

Figure 4 Monthly evaluation of electrical failures generated in an axial machine (2016-2017)

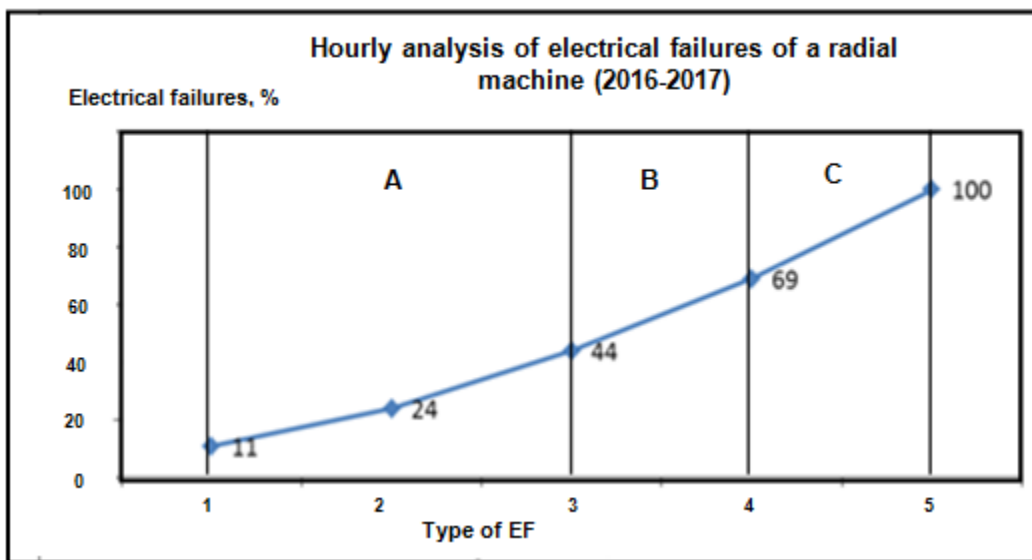
Figure 5 Hourly evaluation of electrical failures generated in a radial machine (2016-2017)

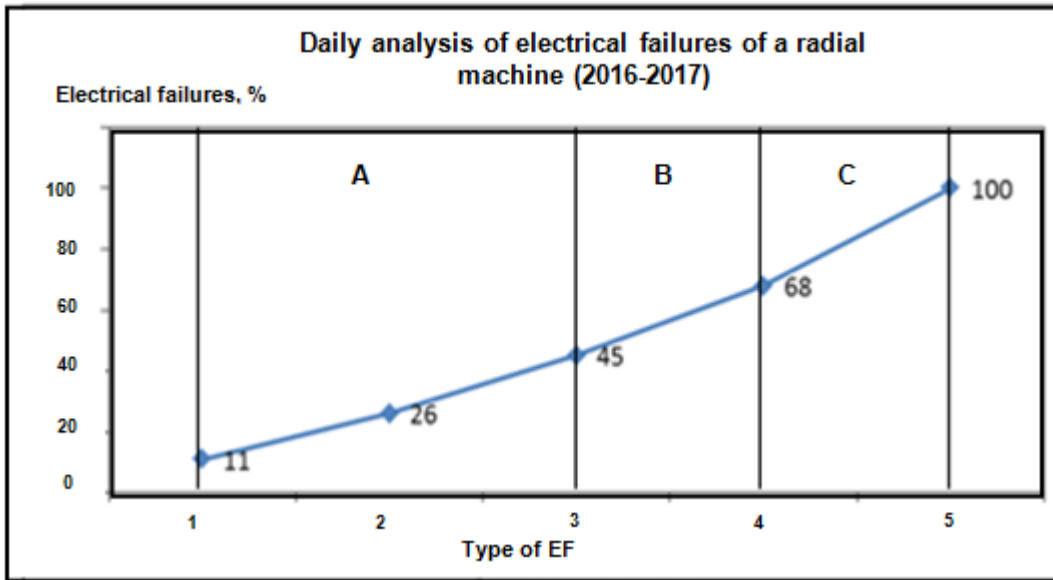
Figure 6 presents percentage indices of the radial machine in the daily period, being 45% in area A, 68% in B and totaling 100%, region C, which indicates that, like the previous graphs, Three first types of FE represent about 70%.

Figure 6 Daily evaluation of electrical failures generated in a radial machine (2016-2017)

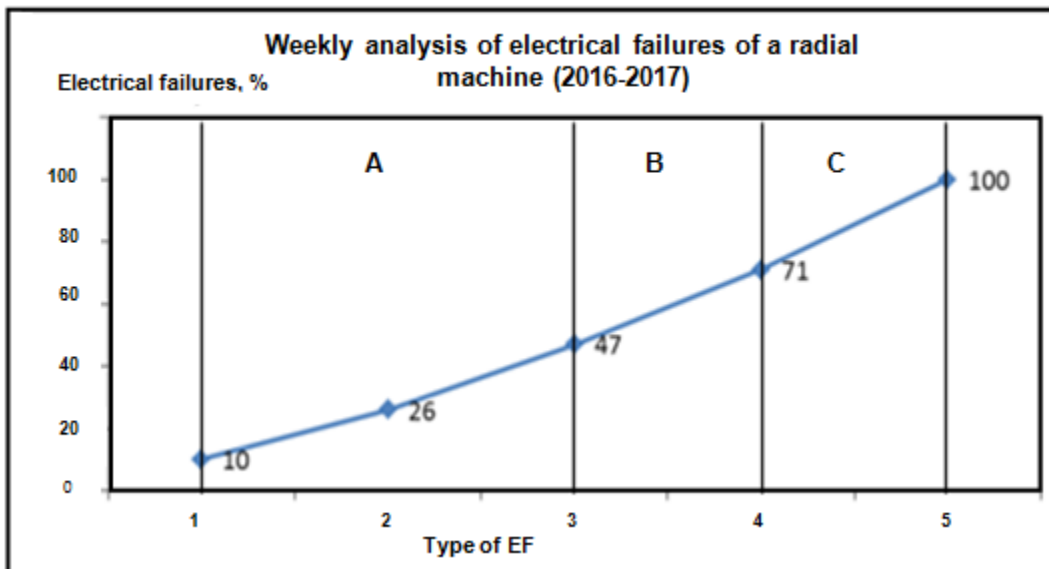
The analysis in figure 7 shows how the percentage rates of the radial machine with a weekly evaluation, being in region A 47%, continuing with region B that exceeded 70% (71%) and ending area C that entails to 100%.

Figure 7 Weekly evaluation of electrical failures generated in a radial machine (2016-2017)

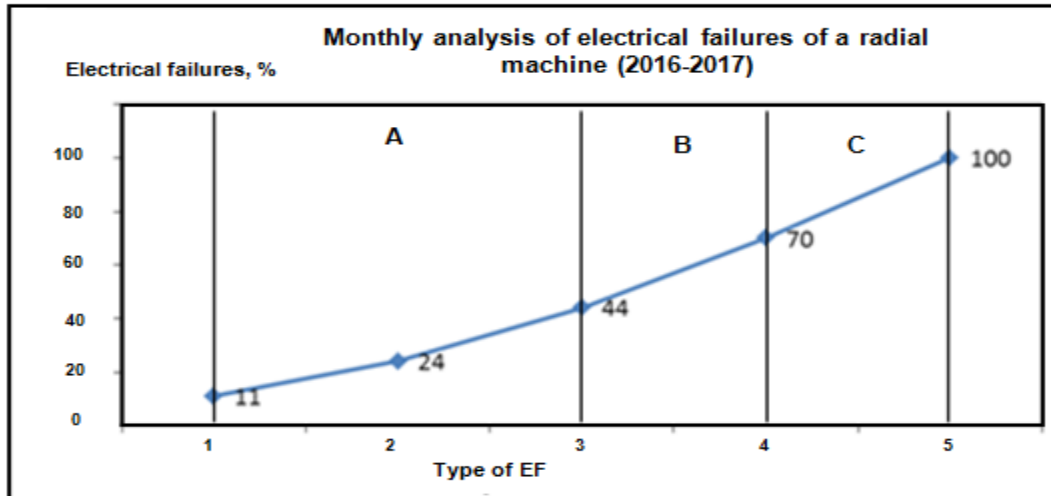
Figure 8 is part of the analysis of the radial machine in the monthly period showing percentage levels of 44% in zone A, 70% in region B and finally area C indicating 100%.

In this graph, the differences between zones are contemplated to determine which of the five types of electrical faults evaluated, can be evaluated quickly and easily to gradually eliminate FEs that cause the concern of all personnel working in this area of the company.

**Figure 8 Monthly evaluation of electrical failures generated in a radial machine (2016-2017)**

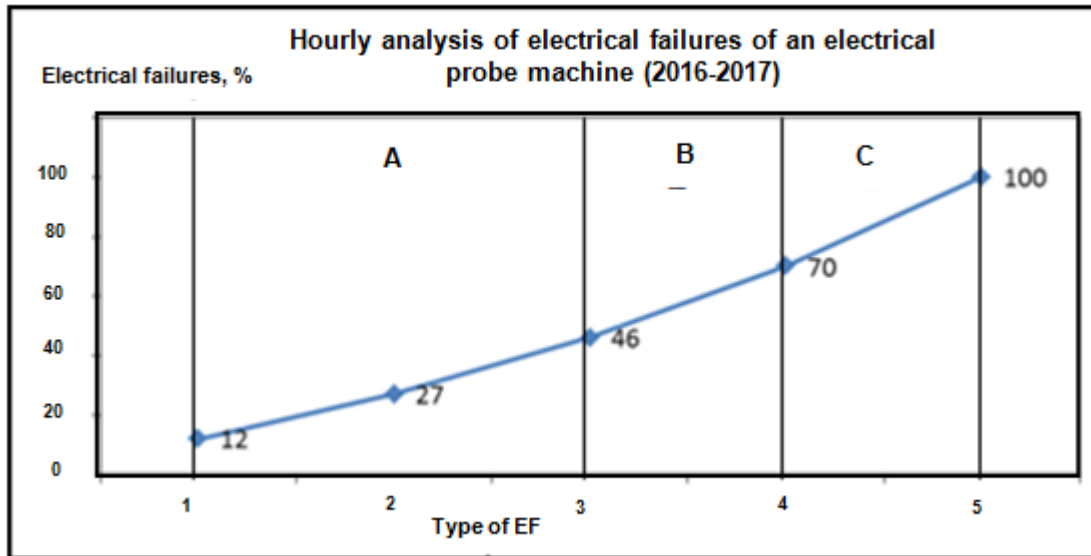
Figure 9 shows the percentages for zone A of 46%, for B for 70% and C for 100% of the percentage distribution with a difference of 30% with respect to area A. This indicated a tendency similar to the previous ones and it is of great support in the elimination of these types of FE. Figure 10 shows the percentage indices of 45% for region A, 69% for zone B and ending with 100% and with a difference of 31% with respect to zone B.

Figure 9 Hourly evaluation of electrical failures generated in a electrical probe machine (2016-2017)

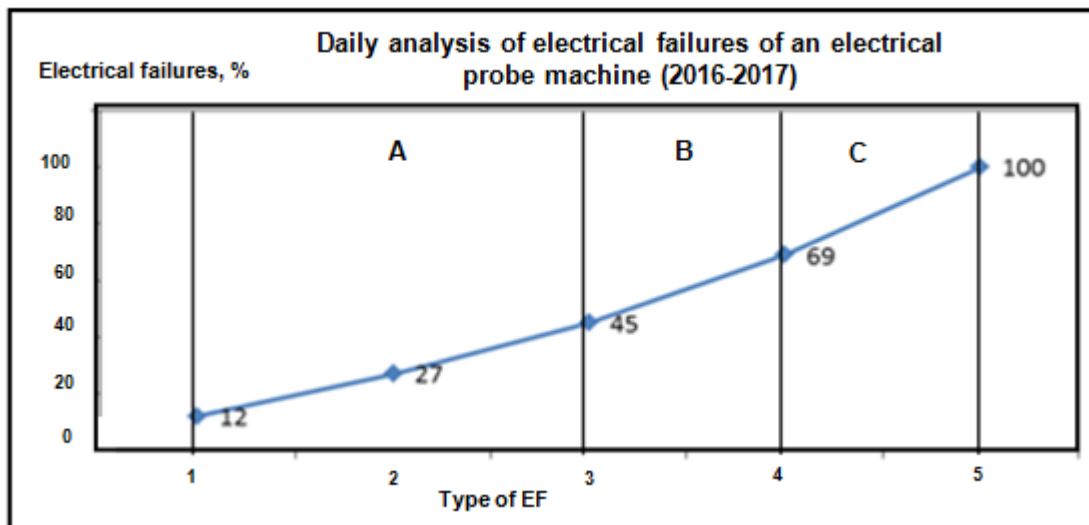
Figure 10 Daily evaluation of electrical failures generated in a electrical probe machine (2016-2017)

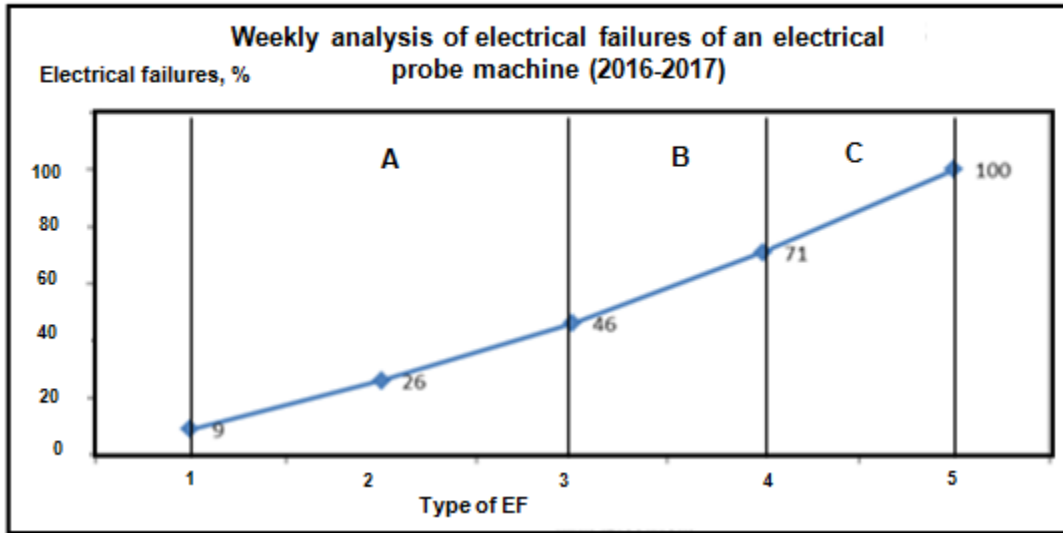
Figure 11 shows the percentage indices for region A of 46%, as well as 71% for zone B and the rest area C. The levels for figure 12 are 44% for zone A, 69% for B and 100% for region C.

Figure 11 Weekly evaluation of electrical failures generated in a electrical probe machine (2016-2017)

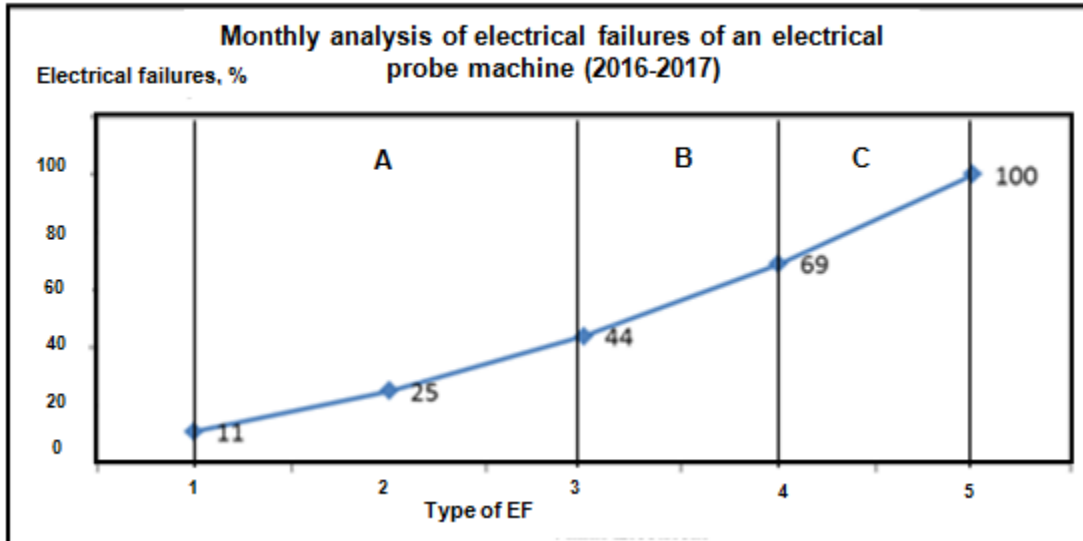
Figure 12 Monthly evaluation of electrical failures generated in a electrical probe machine (2016-2017)

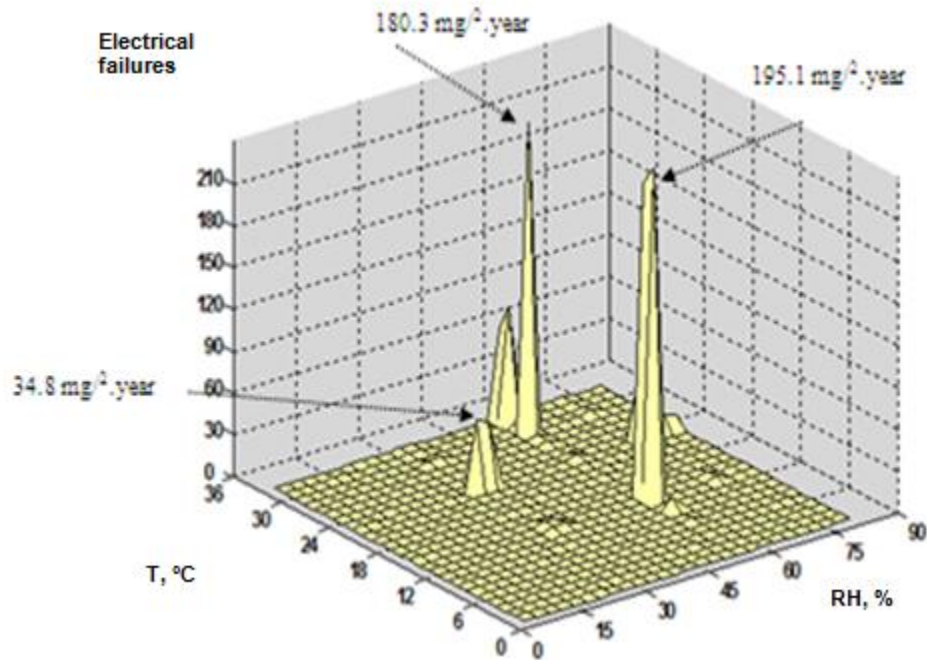
Figure 13 that shows the analysis of 2010, presents the deterioration indexes with corrosivity levels (NC) as shown in the graph. The two highest values of the CV that were presented are 180.3 mg / m<sup>2</sup>.year and 195.1 mg / m<sup>2</sup>.year at HR values of 59% with a temperature of 11.3 ° C and 62% and 31 ° C. The lower index of the VC was 34.8 mg / m<sup>2</sup>.year with a RH of 31% and with a temperature of 22 ° C.

**Figure 13 Correlation of electrical failures and climatic factors of an axial machine in winter (2016-2017)**

Once the evaluations with the ABC Charts were made, a correlation analysis of the climate variables, electrical faults and the corrosion rate (VC) was carried out, which indicates the degree of deterioration of the electrical connections and connectors of the electronic equipment and systems of the electronic industry. Evaluations were carried out for the winter season in each year of the study and in the axial machine, as it was where the FE were presented.

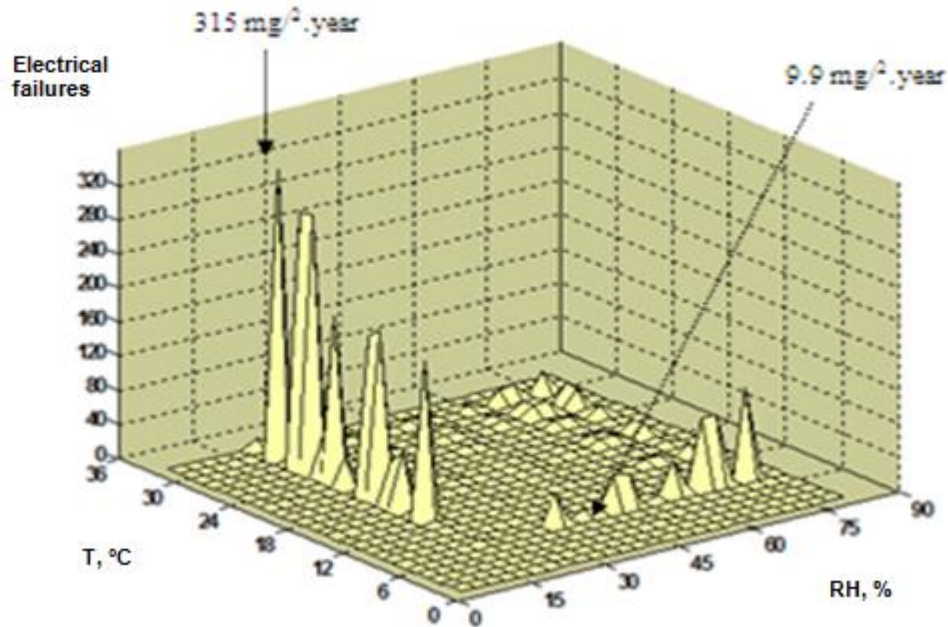
For the years 2016 and 2017 in winter, the analysis of the VC correlated with the parameters of climate, air pollution in the interior of the industry where the study was carried out, and its relation with the electrical faults of the industrial machinery is presented in figure 14.

The following graph shows the VC greater than 315 mg / m<sup>2</sup>.year at a RH of 21% and a temperature level of 32 ° C, and a VC of less than 9.9 mg / m<sup>2</sup>.year at a RH of 38% and an index of 8 ° C temperature.

**Figure 14** Correlation of electrical failures and climatic factors of an axial machine in summer (2016-2017)
